# Lead-free solder pot contamination

Nigel Burtt  
Production Engineering Manager  
Dolby Laboratories, Inc. – European HQ

Lead-Free Wave and  
Selective Soldering  
Workshop

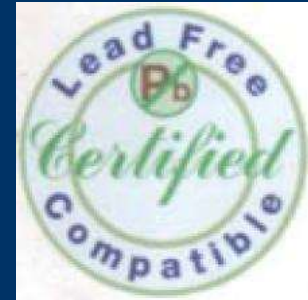
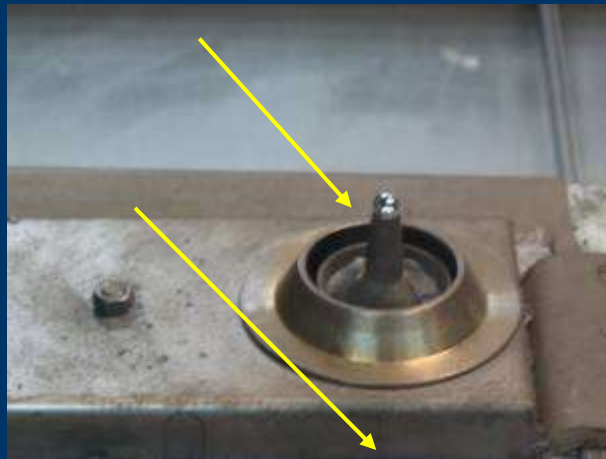
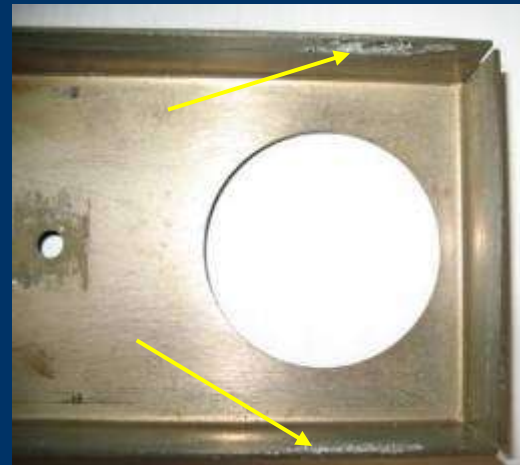
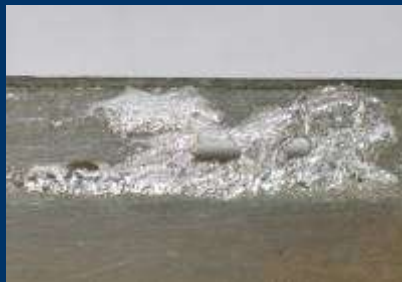
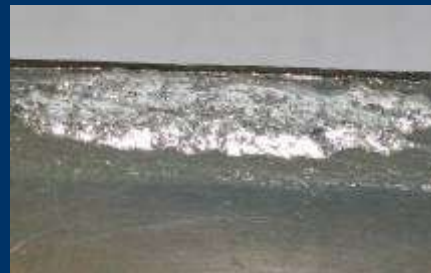
# Selective solder – nickel contamination source (1)

- Nitrogen Shroud above solder pot – erosion around nozzle mount
  - Made from plain 316 stainless steel even though fitted to a machine supplied as “certified lead-free compatible”
  - Same problem with machine in our US factory
  - Had to replace with Chromium Carbide treated version

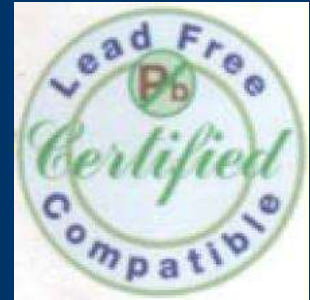
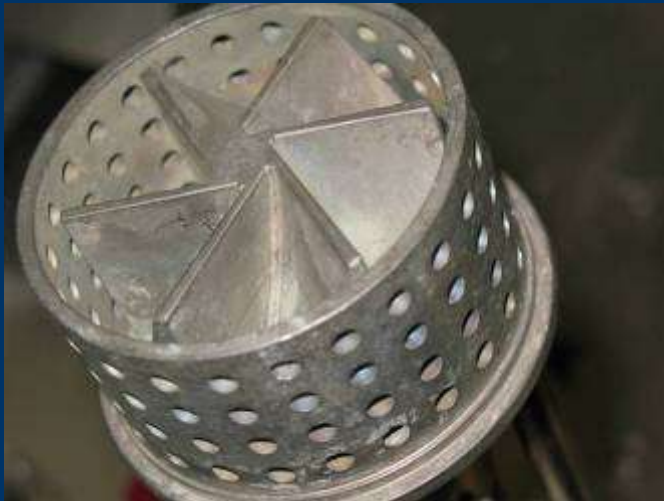
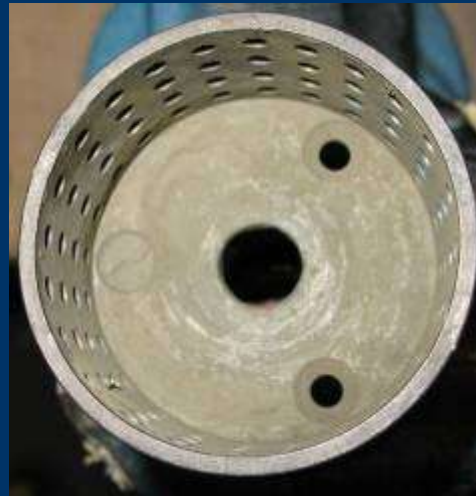
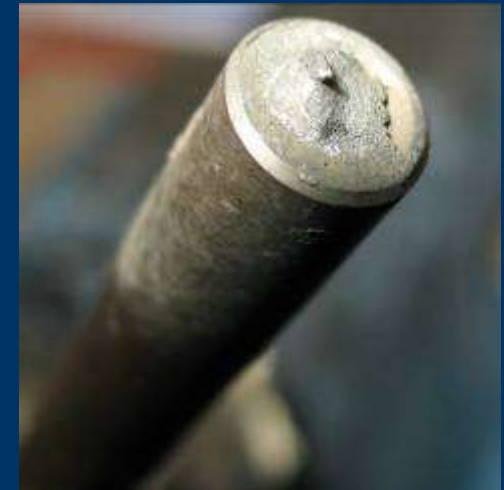
## Selective solder – nickel contamination source (2)

- Pumphouse around impeller came loose
  - 2 out of 3 stainless steel screwheads completely eroded away
  - Replaced with titanium screws which we sourced ourselves

- Separate analysis of dross from this machine showed high levels of Iron contamination (10X that in solder sample)
  - **IMPORTANT TO DE-DROSS REGULARLY AND DO IT WELL!**

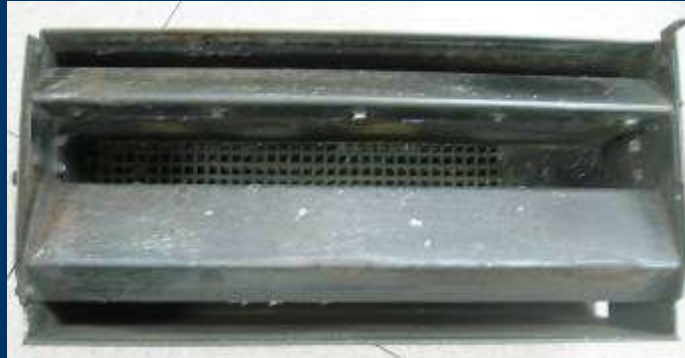
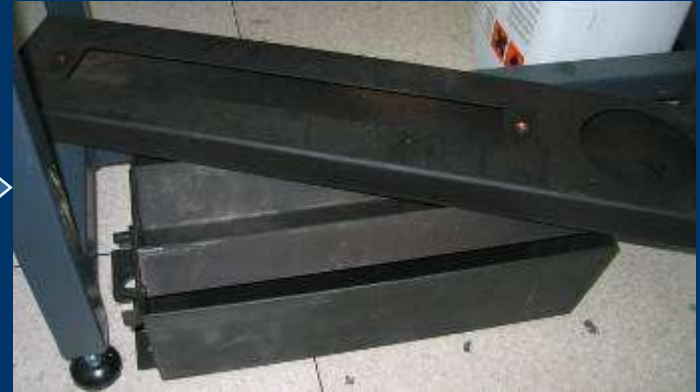
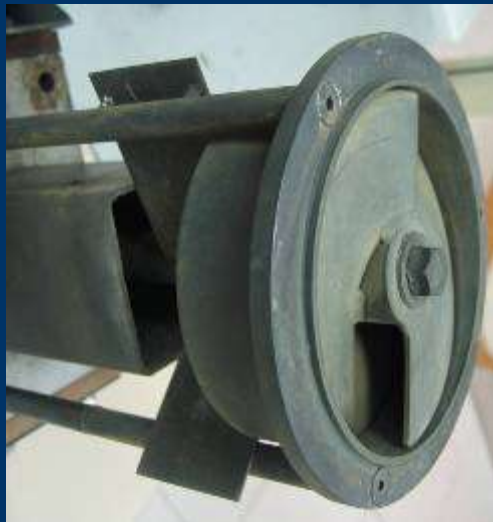
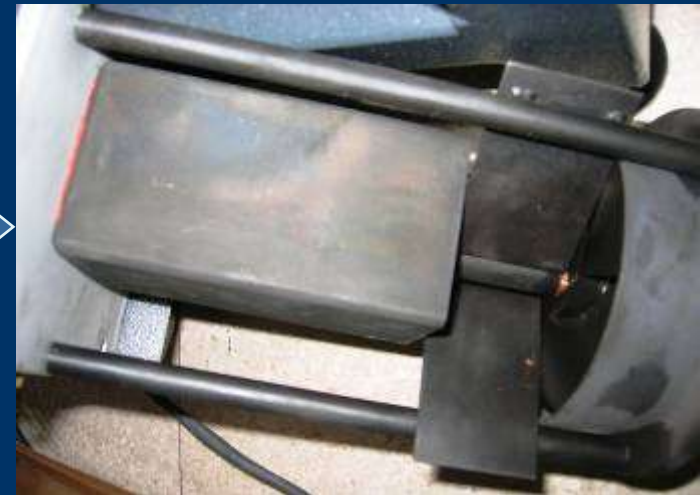
# Wave solder – nickel/iron contamination?

- Pump, Impeller, wave ducting and nozzle replaced with new
  - No obvious signs of erosion on removed parts however

New parts for  
old
